# Manhole Inspection Summary

Manhole # S47C2\_001MH

Insp Date: **1/28/08 10:31 AM**

**Location** Address: **3901 Curtis Ave**

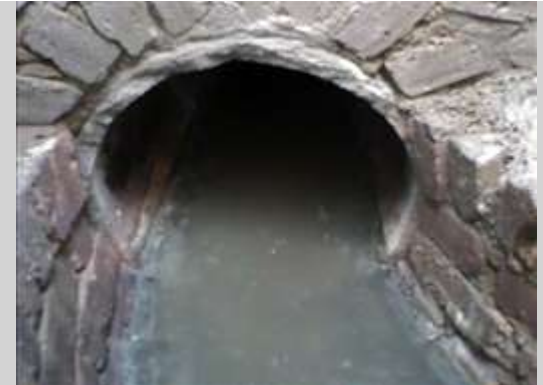
12 O'Clock Outflow

15 in. Circular Gravity Sewer  
Pipe Out @ 12 O'Clock

Pipe Height: **15.6** (in.) Rod and Bar (Angled)  
Pipe Material: **Clay** ☐ Pipe Lined  
Invert Depth: **5.13** (ft.) Flow Characteristics: **Fast**  
Deposits: ☒ None ☐ Mud ☐ Sludge ☐ Debris ☐ Grease  
Silt Depth: (in.) Deposits Extent:  
Infiltration: **None** Pipe Seal Cond: **Sound**

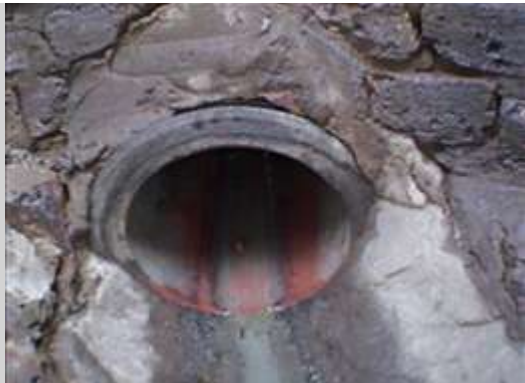
7 O'Clock Inflow

8 in. Circular Gravity Sewer

Pipe In @ 7 O'Clock

Pipe Height: **8.4** (in.) Rod and Bar (Angled)

Pipe Material: **Clay** ☐ Pipe Lined

Infiltration: **None** Pipe Seal Cond: **Sound**
